PUBLIC ROADS

A JOURNAL OF HIGHWAY RESEARCH

Page
Highway Signs and Markings for Blackout Conditions	105
Volcanic Cinders Suitable for Use in Base Course Construction	125
Disposition of State Motor-Fuel Tax Receipts, 1941	137
Disposition of State Motor-Vehicle Receipts, 1941	138
Disposition of State Motor-Carrier Tax Receipts, 1941	139
Disposition of Receipts from State Imposts on Highway Users, 1941	140

HIGHWAY SIGNS AND MARKINGS FOR BLACKOUT CONDITIONS

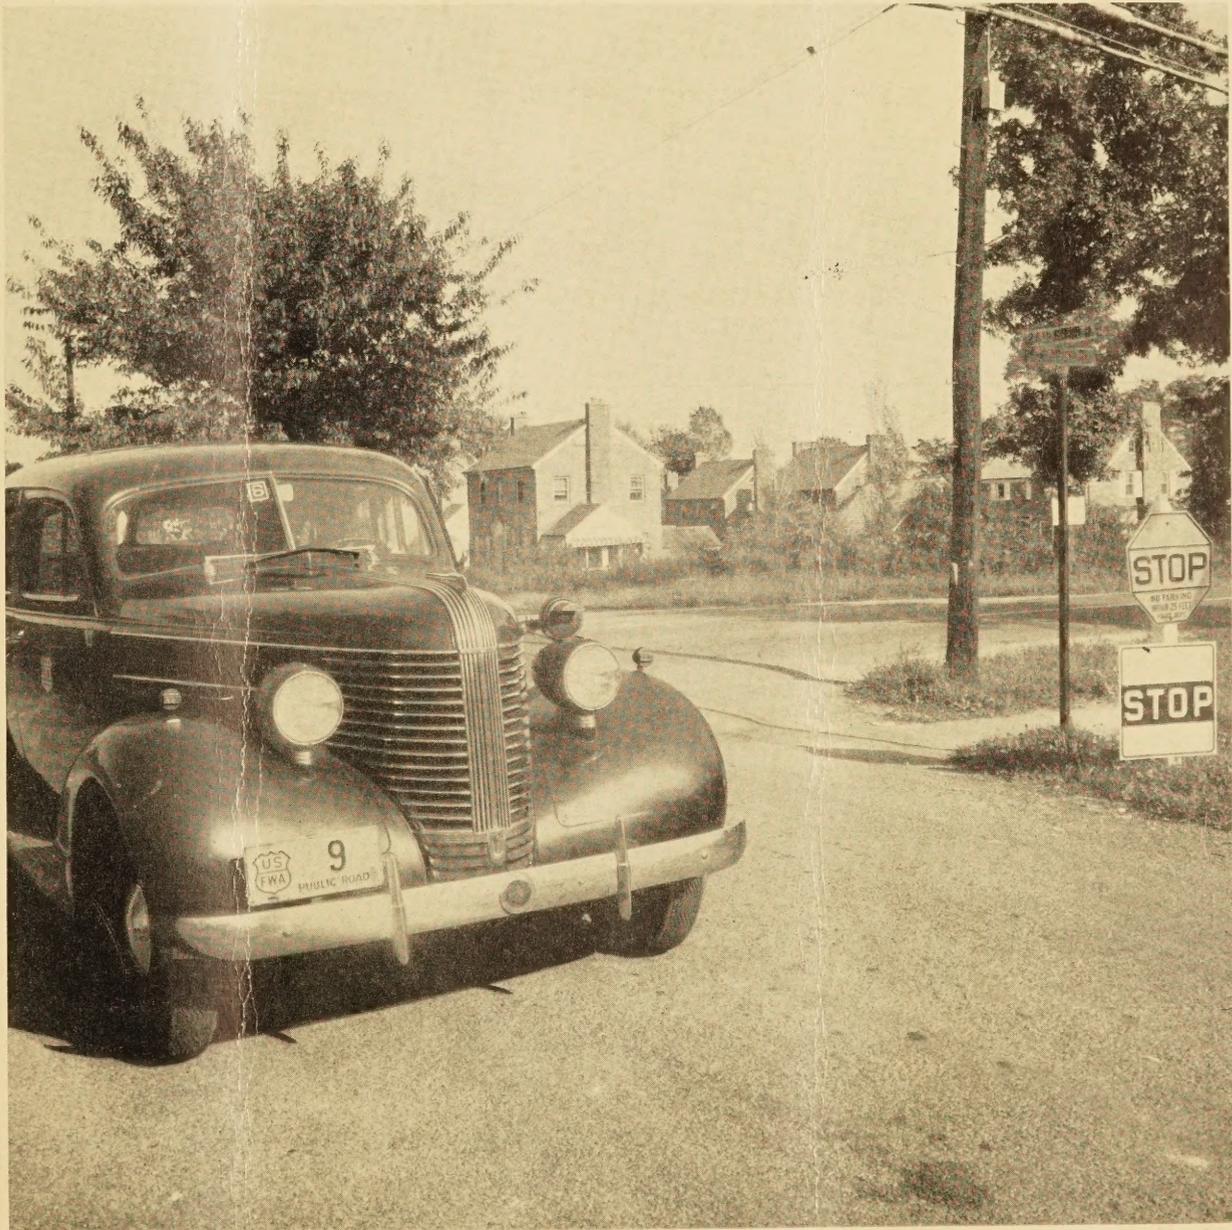
BLACKOUT HEADLAMP ILLUMINATES ONLY LOW SIGNS AND MARKINGS

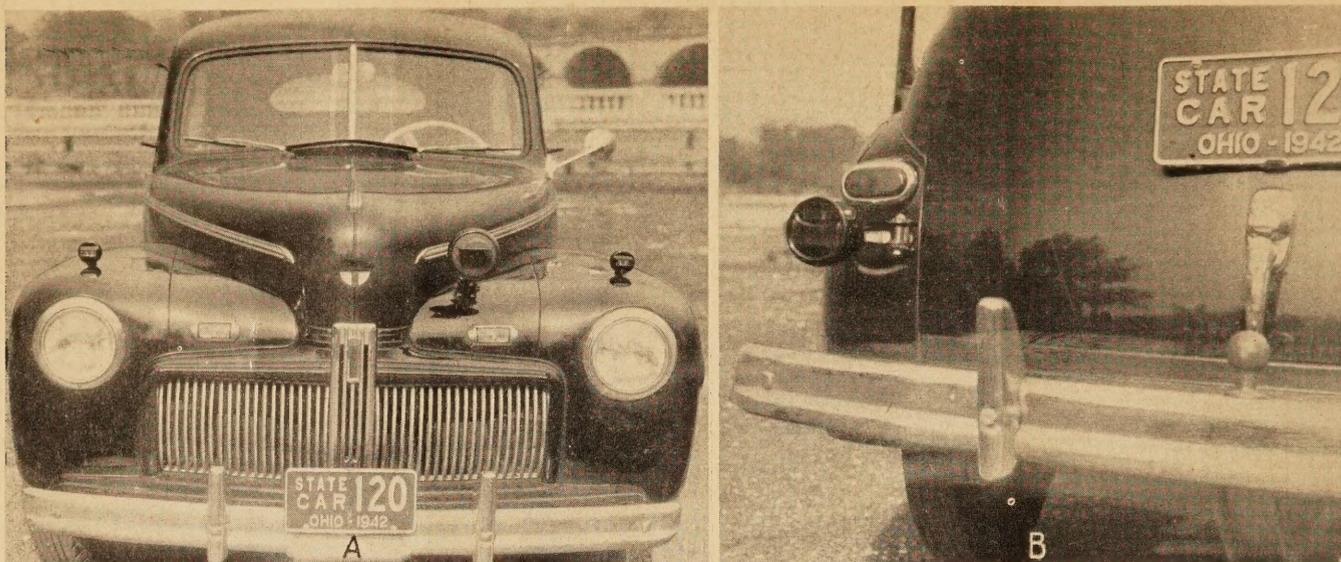
FIGURE 1.—AUTOMOBILE EQUIPPED WITH APPROVED BLACKOUT HEAD LAMP, MARKER LAMPS, AND COMBINATION STOP AND TAIL LAMP.

The approved blackout lighting system for civilian vehicles, decided upon after extensive tests by the Blackout and Traffic Control Branch of the Engineer Board of the War Department, consists of one head lamp, two front clearance lamps, and a combination stop and tail lamp (fig. 1). The head lamp or driving lamp emits a beam that has only a small fraction of the intensity of an ordinary seal-beam headlight. It must

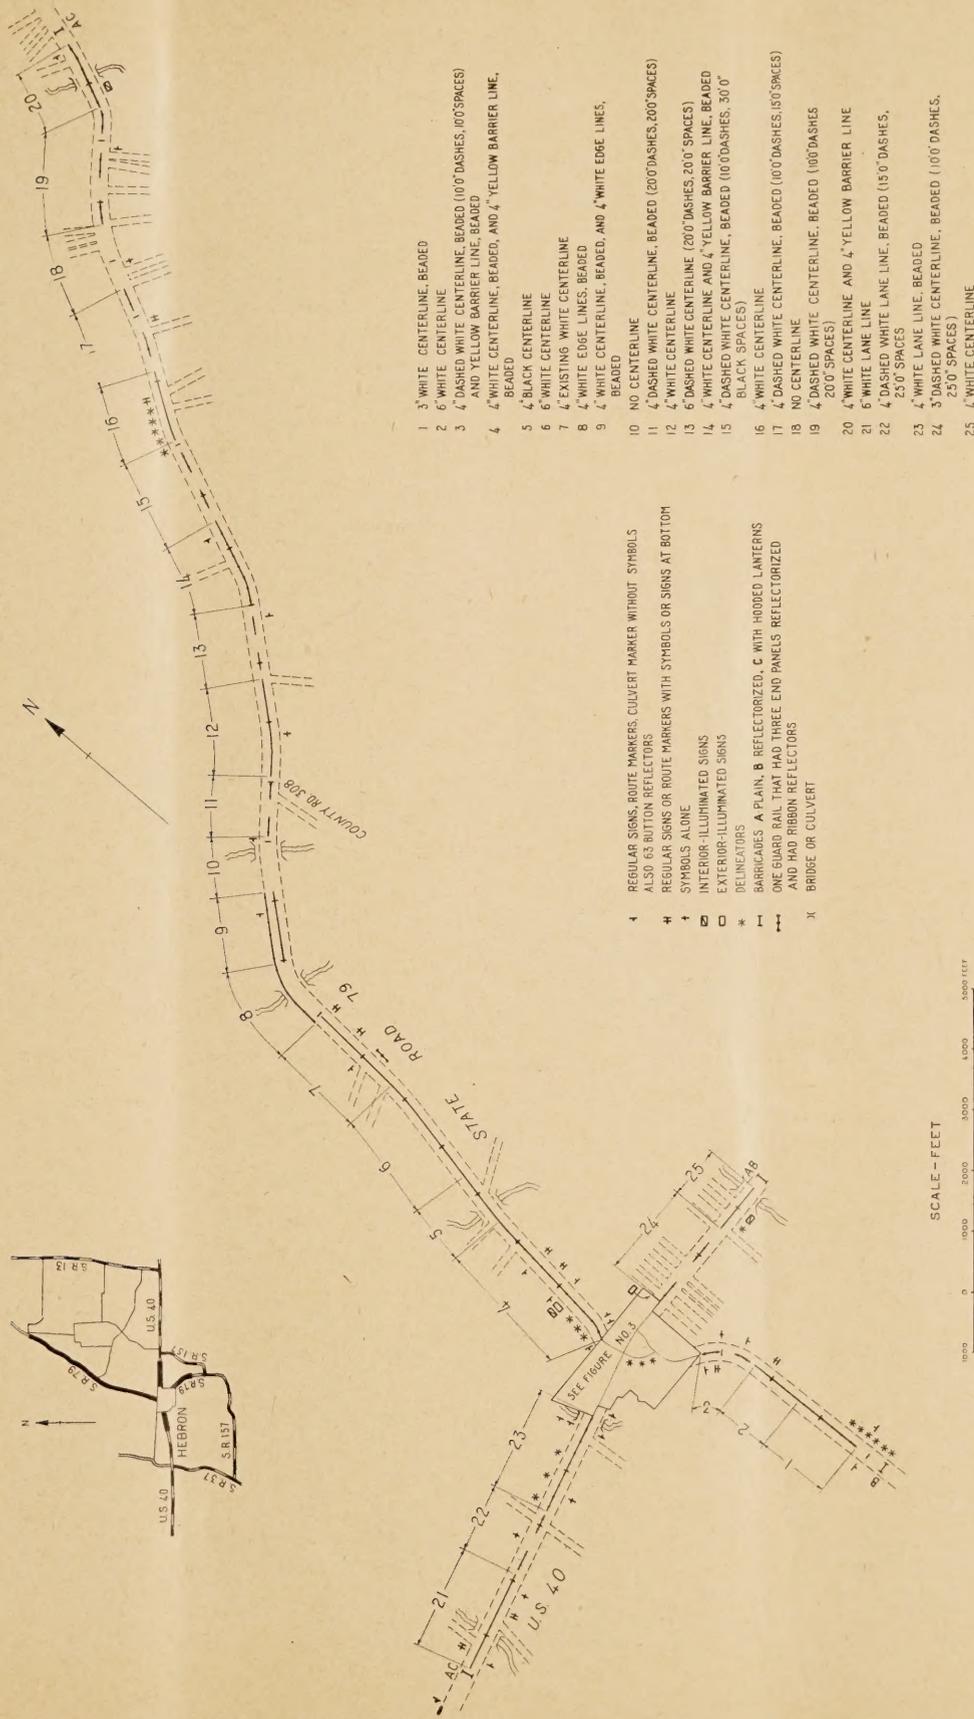
FIGURE 2.—CENTERLINES, PAVEMENT EDGE LINES AND SPECIAL MARKERS ON RURAL SECTIONS OF TEST ROUTE.

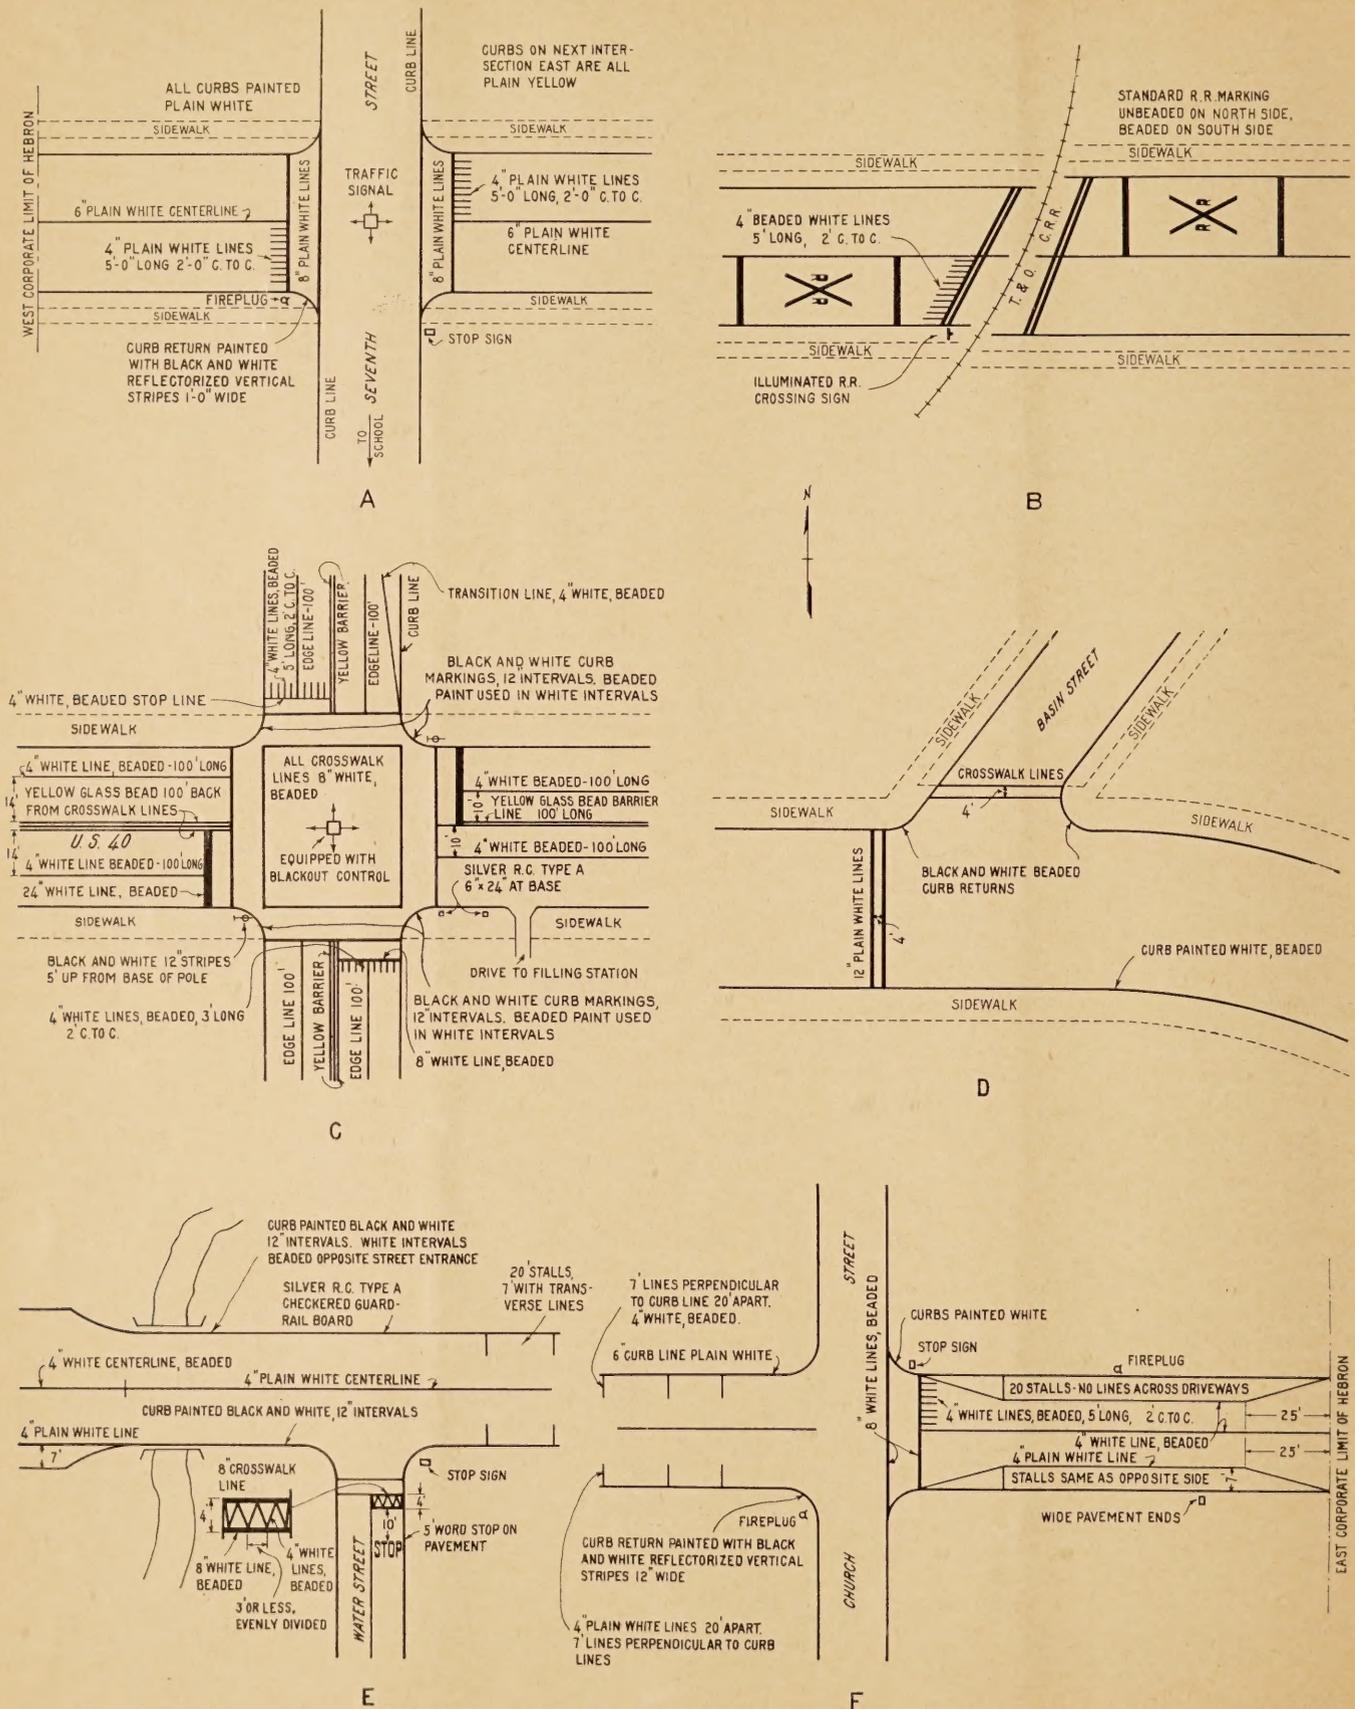
FIGURE 3.—PAVEMENT AND SPECIAL MARKINGS ON URBAN SECTION OF TEST ROUTE.

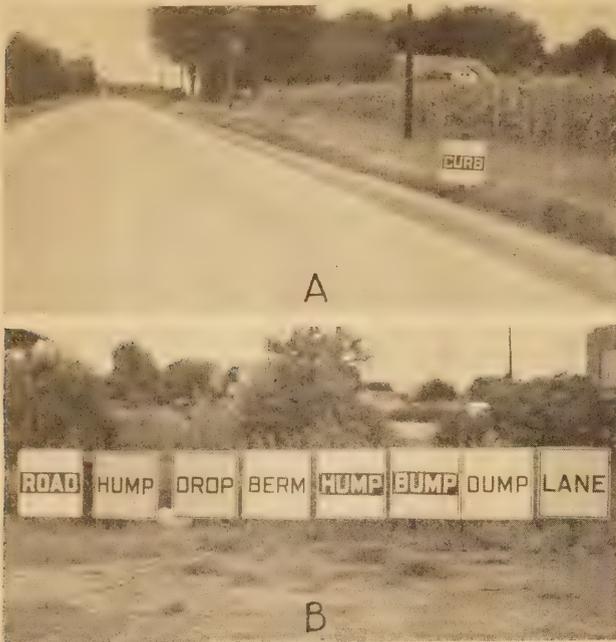
FIGURE 7.—SPECIAL SIGNS USED FOR TESTS; A, PLACED ALONG ROUTE; B, BATTERY OF SIGNS VIEWED FROM STATIONARY VEHICLE.

At one of the turn-around areas, eight test signs were mounted side by side just above ground level (fig. 7-B). As each test vehicle turned, the driver stopped with the car facing the battery of signs, and as far away as it was possible for him to read the legends on most of the signs. He then rated the signs in the order of preference.

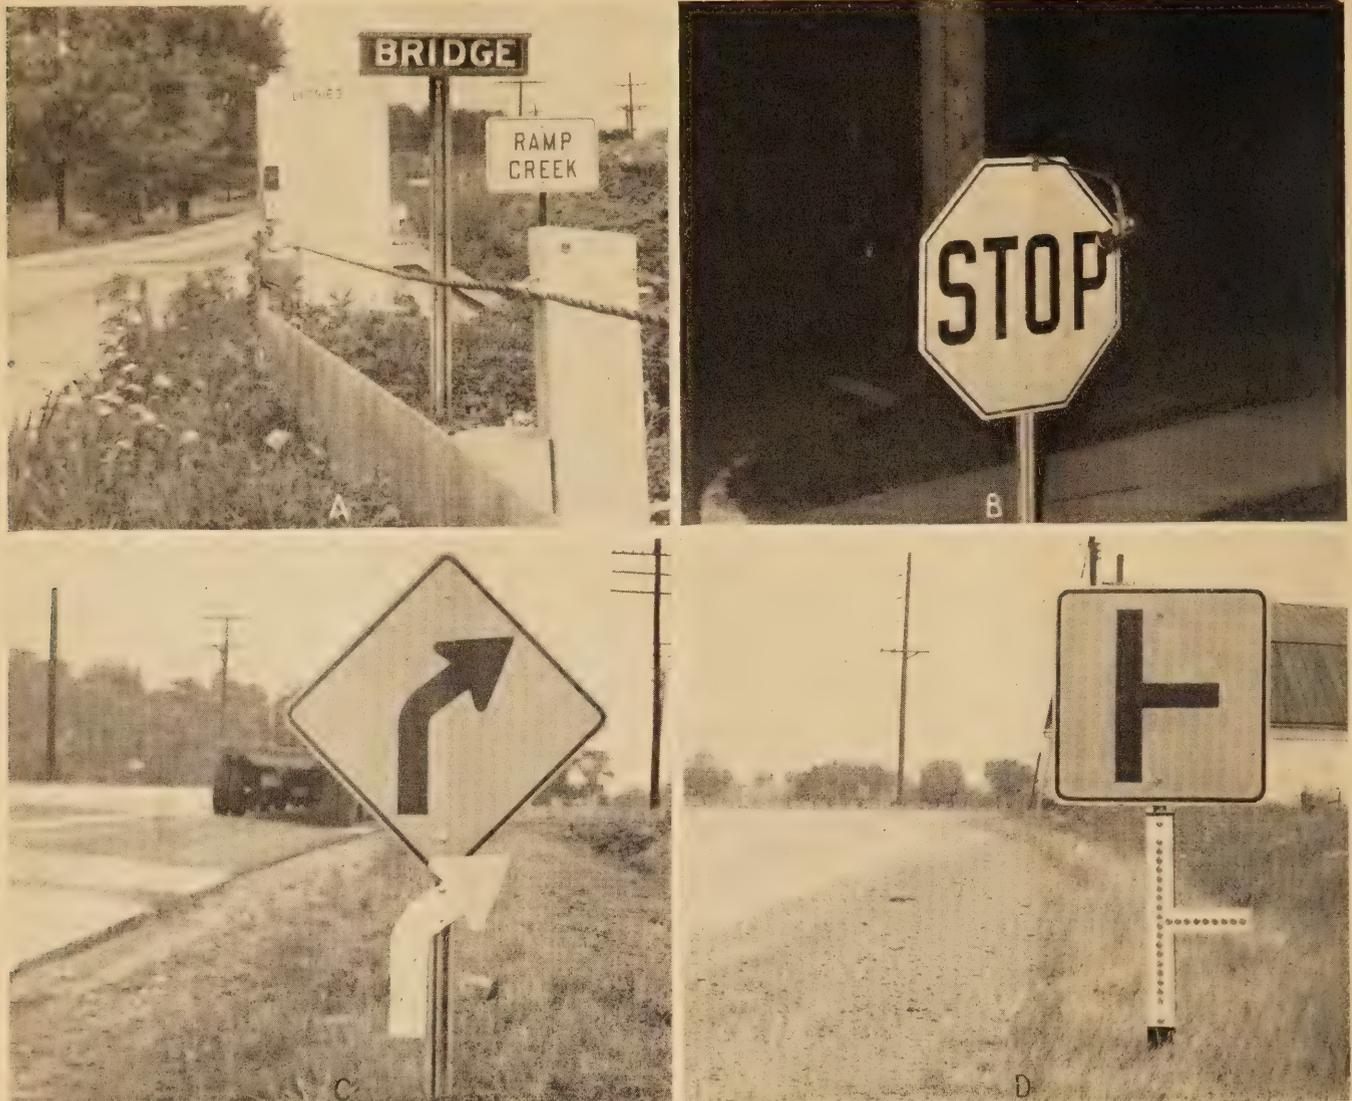
FIGURE 8.—TRAFFIC SIGNS TESTED UNDER BLACKOUT CONDITIONS. A, INTERIOR-ILLUMINATED BRIDGE SIGN; B, STANDARD STOP SIGN ILLUMINATED BY EXTERIOR LIGHT; C, ARROW SYMBOL WITH REFLECTORIZED COATING MOUNTED BELOW STANDARD SIGN; D, SIDE ROAD SYMBOL REFLECTORIZED WITH GLASS BUTTONS MOUNTED BELOW STANDARD SIGN.

Two types of illuminated signs meeting War Department Specifications for blackout conditions⁶ were tested. One type (fig. 8-A) was an interior-illuminated sign in the shape of a box 19 inches long, 6 inches wide, and 4½ inches high. The transparent face of the sign was painted black with the exception of the legend which was of rounded letters 3 inches high made with a stroke ½ inch wide. Inside the box were a No. 6 dry cell battery and three 1.35-volt 0.06 ampere bulbs that will operate continuously for about 1 week with either a No. 6 dry cell or 10 standard flashlight batteries in parallel. Both ground glass and opal glass were used for the face of these signs. Three signs of each material were mounted along the test route at a height of 4½ to 6 feet above the pavement surface.

the top of a standard nonreflectorized sign so that the legend was illuminated. The light consisted of a 1.35-volt, 0.06-ampere bulb with a flashlight reflector painted white. Two types of mountings were used. One consisted of a single-battery flashlight, with the lens removed, held in position by an arm extending out from the signpost (fig. 8-B). The other consisted of a curved metal arm with a clamp holding a No. 6 dry cell and light bulb that fastened to the top of the sign. Both the battery and light bulb were grounded on the metal arm thus requiring only one insulated wire to complete the electrical circuit.

Table 5 shows the results obtained for a variety of special symbols mounted within 24 inches of the elevation of the pavement surface (figs. 8-C and 8-D).

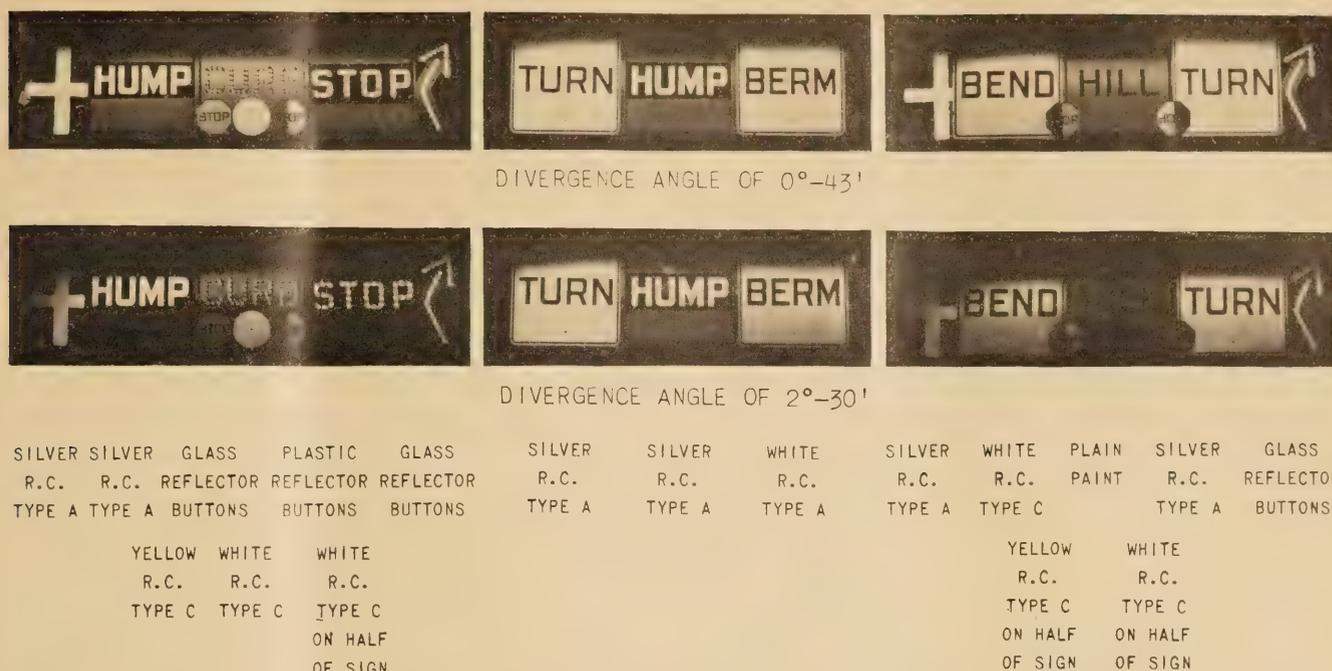
FIGURE 11.—EFFECT OF DIVERGENCE ANGLE ON VISIBILITY AND LEGIBILITY OF REFLECTORIZED SIGNS AND SYMBOLS ILLUMINATED BY BLACKOUT HEAD LAMP. (SAME EXPOSURE TIME USED IN ALL PICTURES.)

Compared to the entrance angle, the divergence angle is much more critical. To be effective for use on signs a glass reflecting button or reflectorized material must be highly retrodirective, that is, it must return the light in approximately the same direction as the source of light. It is therefore common for the brilliance of a reflecting button to decrease more than 50 percent when the divergence angle increases from 1° to 2° (see fig. 11).

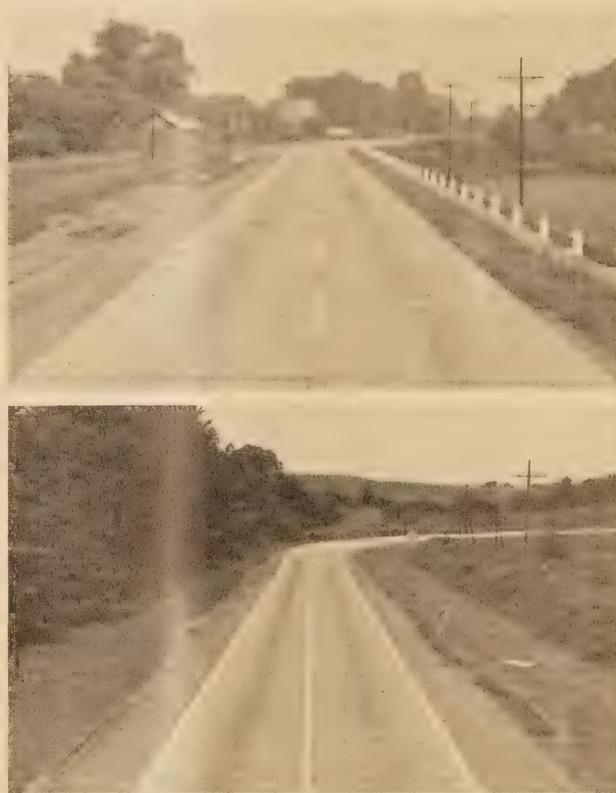
FIGURE 12.—TOP, 4-INCH BEADED WHITE CENTERLINE WITH 20-FOOT DASHES AND 20-FOOT SPACES; BOTTOM, 4-INCH BEADED WHITE CENTERLINE AND EDGE LINES.

5. Dashed centerlines are not as effective as continuous centerlines although they are adequate on tangent sections of highway (fig. 12). Out of 44 observers, 26 stated that the continuous line was definitely better, 13 stated that the continuous line was somewhat better, and 5 had no preference. When a dashed line is used, the dashes should be at least 10 feet long and the spaces not over 20 feet long. Although both designs require the same amount of paint, 10-foot dashes and spaces are preferable to 20-foot dashes and spaces, especially on curves. However, the remarks made by the observers indicate that a solid centerline should be used in place of a dashed centerline even on fairly flat curves.

6. Edge lines when used in conjunction with a centerline (fig. 12) are effective in helping to outline the road surface but are unnecessary and may be confused with lane lines. The comments of the 44 observers regarding the edge lines were as follows:

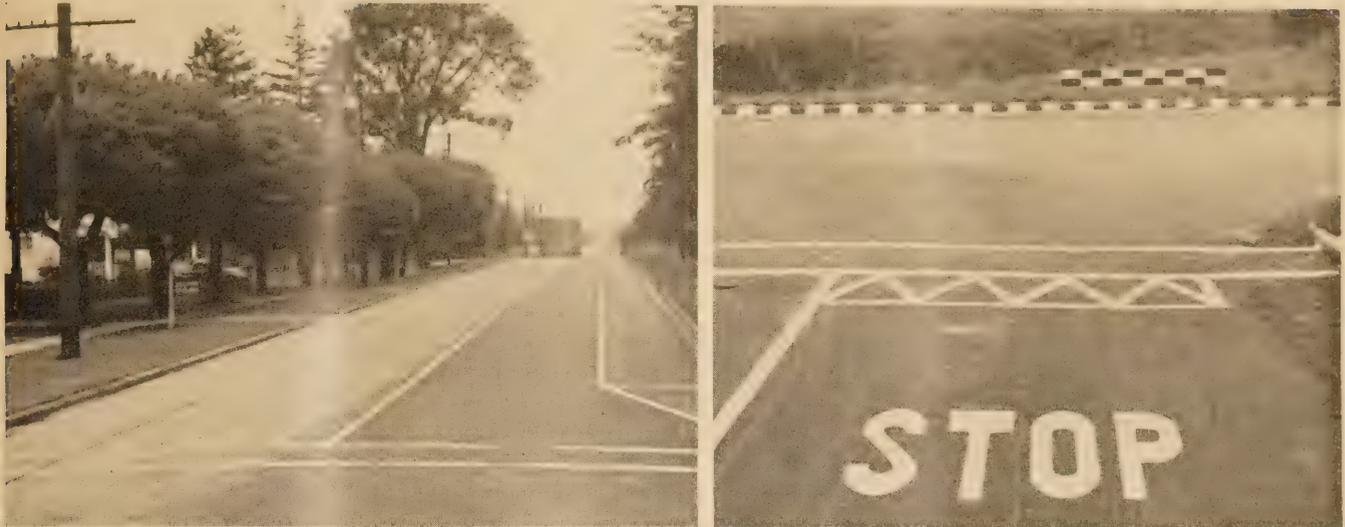
FIGURE 13.—BEADED WHITE PAVEMENT MARKINGS IN URBAN AREAS. LEFT, CENTERLINE, PARKING STALLS, AND “COMB” DESIGN AT CROSSWALK; RIGHT, PAVEMENT AND CURB MARKINGS AT T-INTERSECTION.

Considering the particular locations where these transverse markings were placed, the design with 4-inch lines 5 feet long spaced 2 feet center-to-center and placed perpendicular to a transverse line on the side of approaching traffic to give a "comb" effect (fig. 13) was the most effective transverse marking. Where it is necessary that the pavement marking be visible for 50 feet such as at wide, important intersections where there is a stop light, this design should be used. Increasing the length of the perpendicular bars will, to some extent, increase the visibility distance.

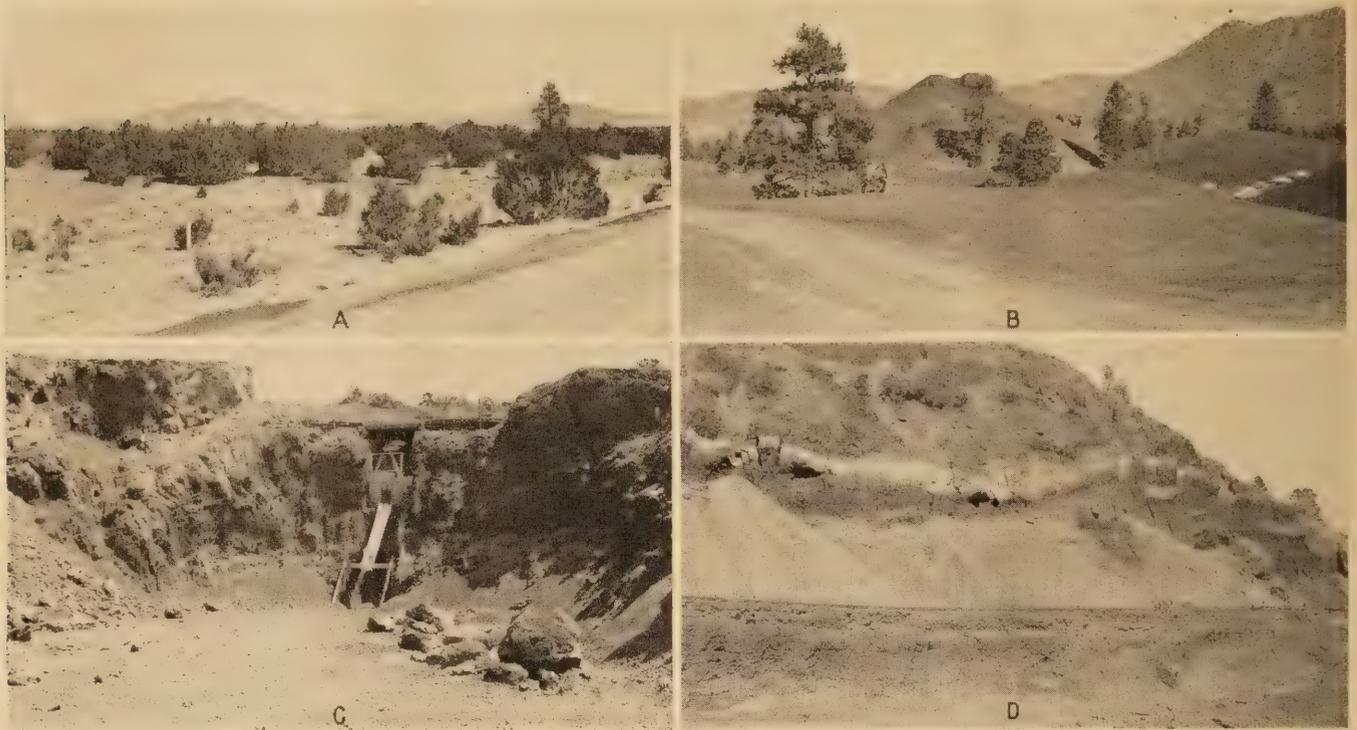
FIGURE 1.—VOLCANIC CINDER DEPOSITS IN ARIZONA. CINDER CONES NORTH OF FLAGSTAFF (A AND B); CINDER PIT EAST OF SHOWLOW (C), AND WEST OF FLAGSTAFF (D).

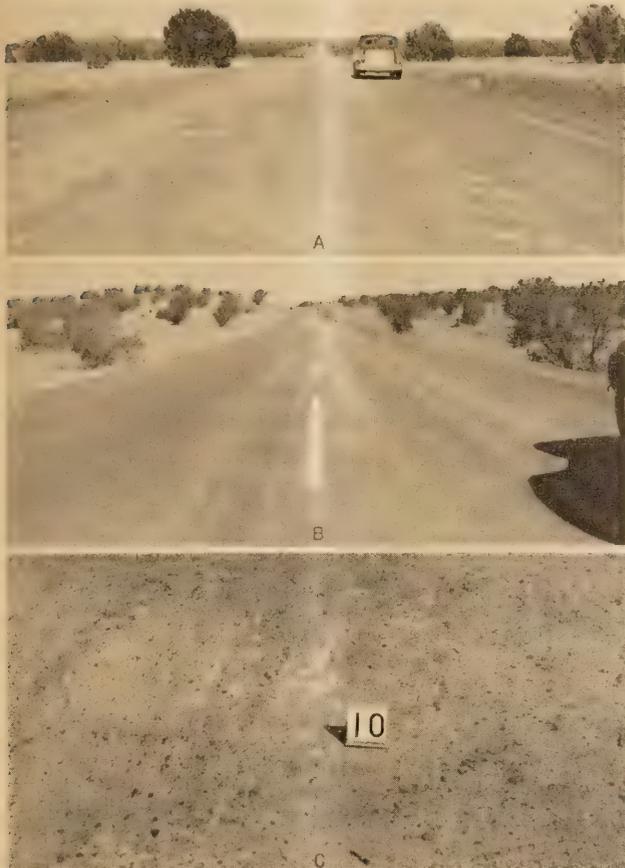
FIGURE 2.—VOLCANIC CINDER ROADS. A, UNTREATED CINDER ROAD TYPICAL OF ALL SUCH ROADS INSPECTED; B, BITUMINOUS TREATED CINDER ROAD IN GOOD CONDITION (FAP 95-J); C, TEXTURE OF ROAD SURFACE SHOWN IN B.

A total of about 83 miles of road were inspected, of which approximately 20 miles were of the bituminous surface-treated type and the remainder was untreated. The untreated surfaces were maintained in uniformly good condition as illustrated in figure 2-A. Since no variation in condition could be observed, no detailed studies were made of the untreated roads.

The bituminous surface treatment consisted of from 0.75 to 1.00 gallon of liquid asphalt (SC-2) applied to a previously sprinkled, rolled, and properly shaped surface. No cover material was spread unless the asphalt was not entirely absorbed. The loose material developed in blading the road during the reshaping process was used for the cover material when required. The asphalt was placed in two applications, the first consisting of 0.5 gallon per square yard and the second varying from 0.25 to 0.50 gallon. The character of the surface obtained in this manner is illustrated in figures 2-B and 2-C.

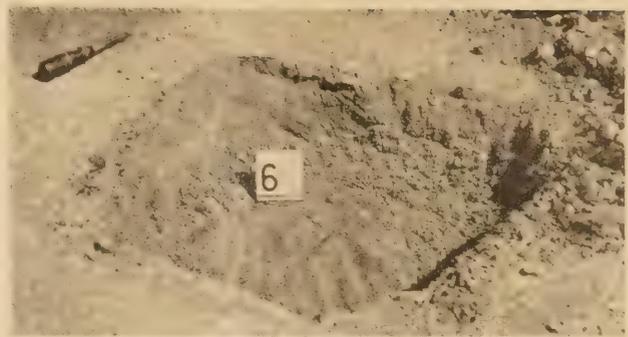
FIGURE 3.—SECTION THROUGH BITUMINOUS PENETRATION MAT AND BASE COURSE. BOTTOM OF EXCAVATION IS TOP OF SUBBASE.

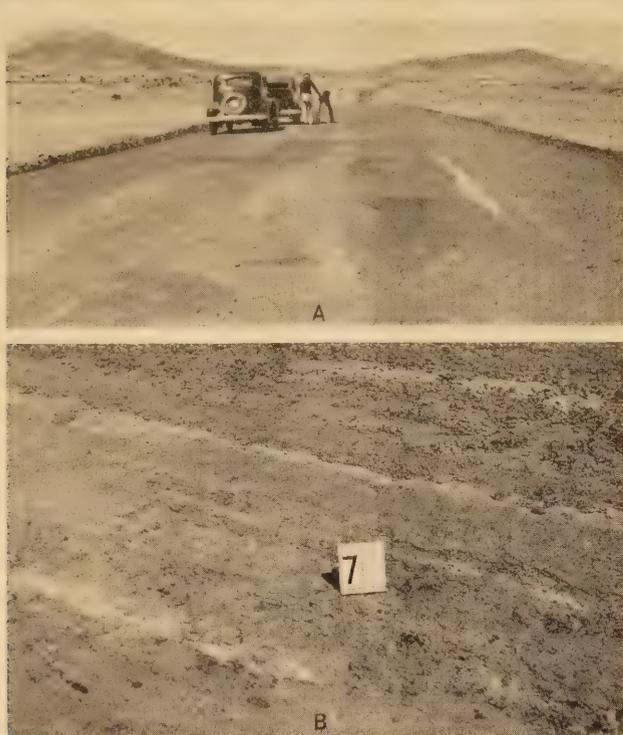
FIGURE 4.—A, FAILED SECTION OF FAP 105-C THAT WAS BADLY CRACKED AND RUTTED; B, CRACKED AND SCALED PORTION OF FAP 105-C.

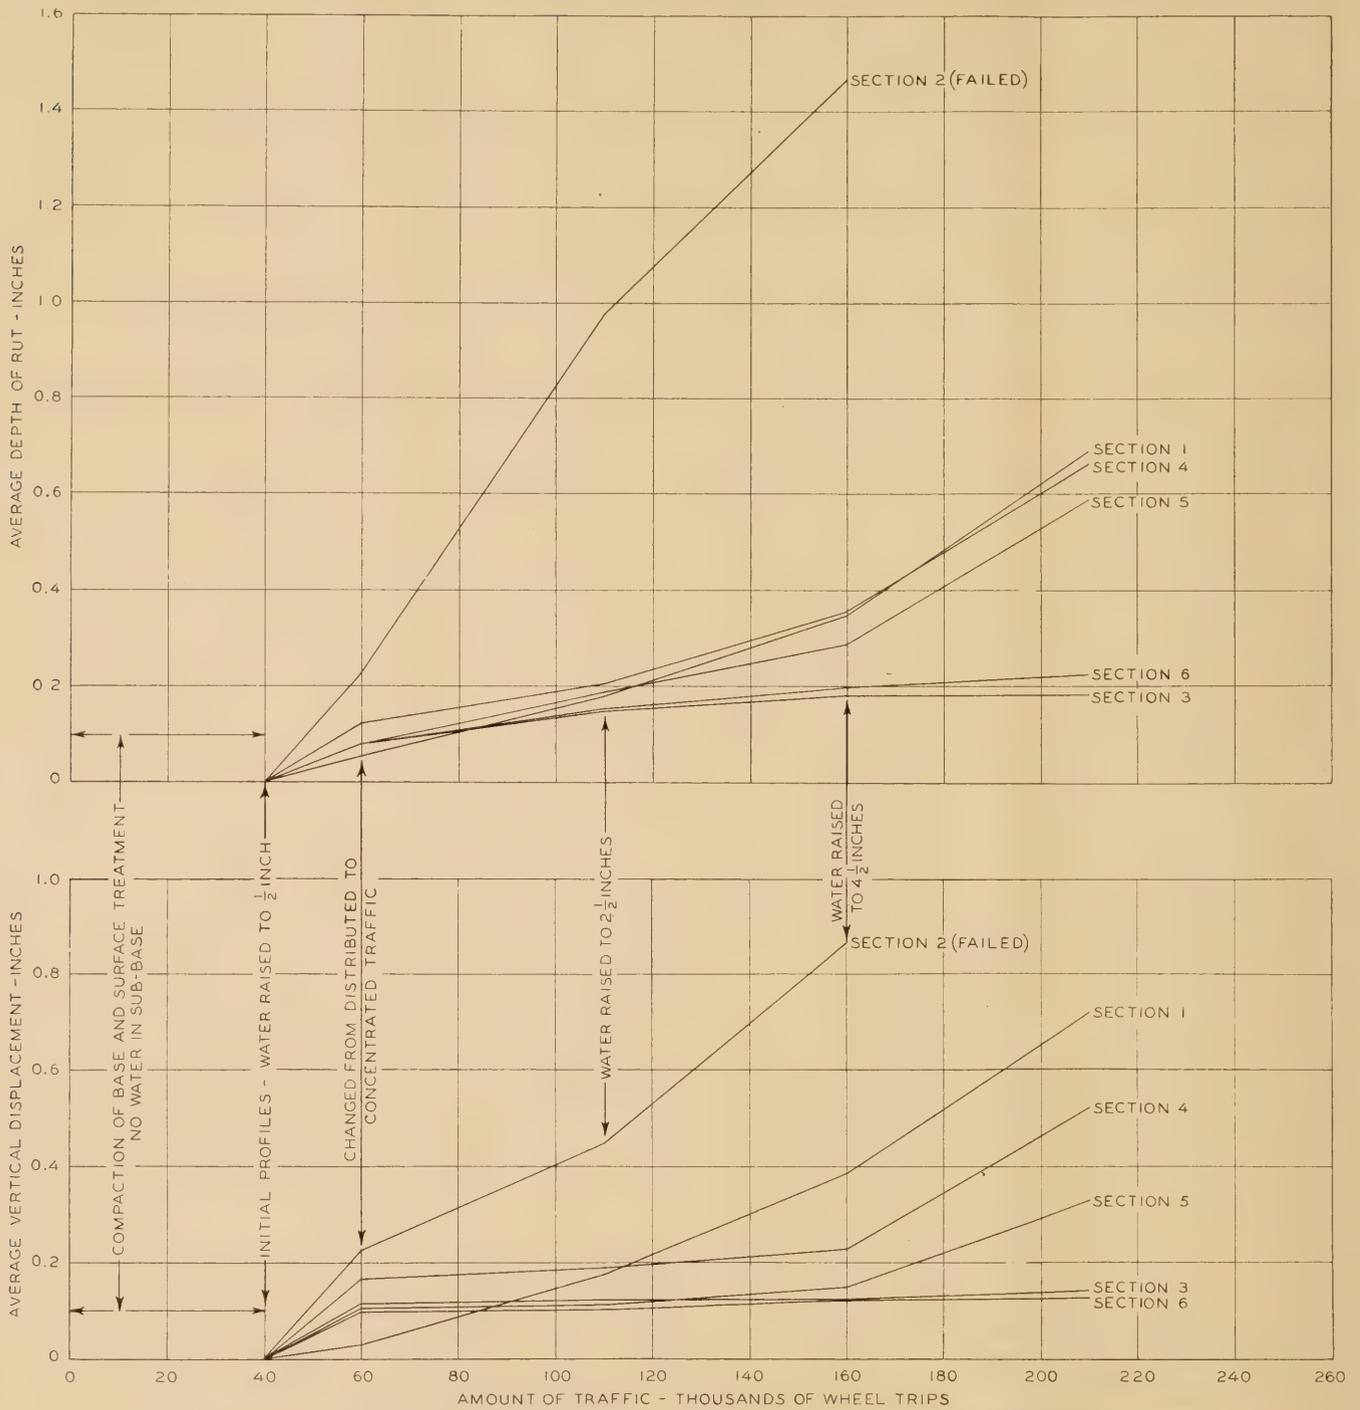
FIGURE 5.—RATE OF SURFACE DISPLACEMENT OF CIRCULAR TRACK TEST SECTIONS UNDER TRAFFIC.

Figure 5 shows changes in behavior of the various sections under altered test conditions. The abrupt changes in the slopes of the displacement curves coincide with the increased severity of test conditions brought about by changing from distributed to concentrated traffic or by raising the ground-water level.

The schedule of traffic applications with notations on the behavior of the six test sections is given in table 7. Initial profile measurements were made at 40,000 wheel-trips. From 40,000 to 60,000 wheel-trips, the sections were subjected to distributed traffic, and the ordinates at 60,000 wheel-trips (fig. 5) represent displacements at the end of such traffic. At 60,000 wheel-trips, concentrated traffic was begun and continued to the end of the test.

gone further compaction. Sections 2 and 4 experienced the most compaction during this interval (see fig. 5).

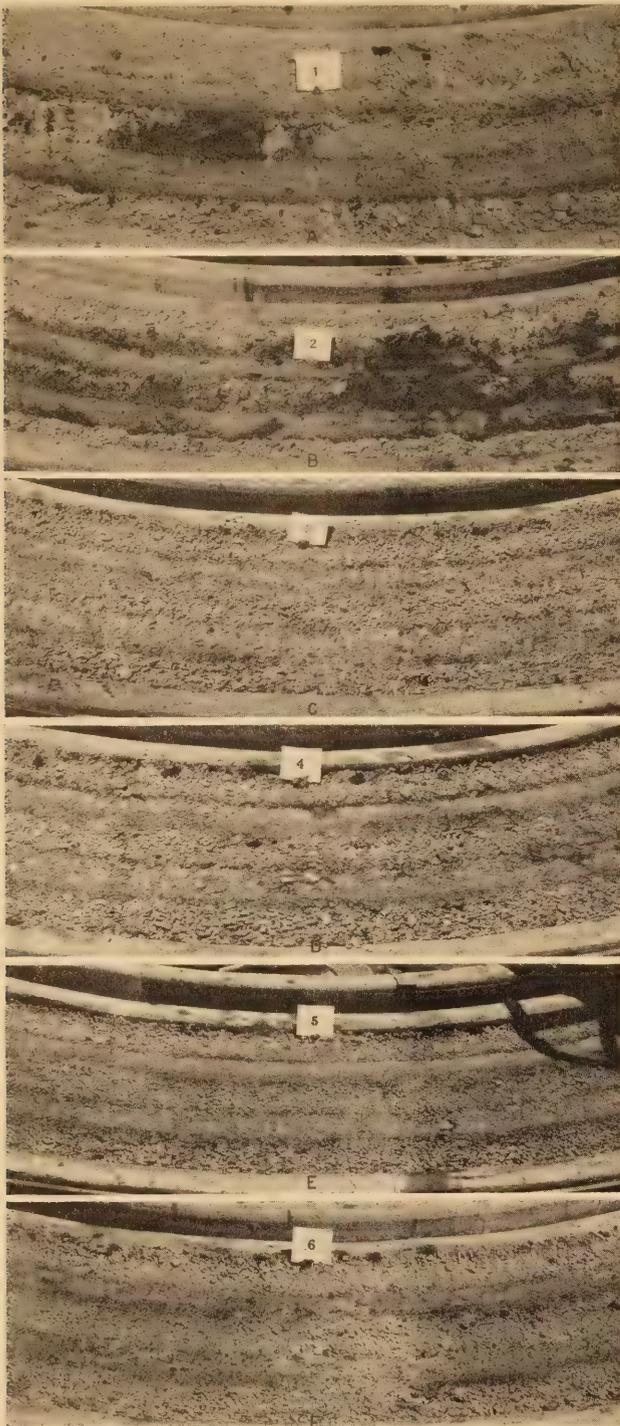
FIGURE 6.—APPEARANCE OF CIRCULAR TRACK TEST SECTIONS AFTER 160,000 WHEEL-TRIPS OF TRAFFIC. A, SURFACING OF SECTION 1 FAILED BETWEEN WHEEL RUTS BECAUSE OF MOVEMENT IN BASE; B, BASE-COURSE MATERIAL OF SECTION 2 SHOVED UP THROUGH SURFACE TREATMENT BETWEEN WHEEL RUTS; C, LITTLE DISPLACEMENT OCCURRED ON SECTION 3, SURFACE TREATMENT IN EXCELLENT CONDITION; D, SOME MOVEMENT TOOK PLACE IN SECTION 4; E, LITTLE DISPLACEMENT OCCURRED ON SECTION 5, SURFACE TREATMENT IN EXCELLENT CONDITION; F, BASE AND SURFACE OF SECTION 6 IN EXCELLENT CONDITION.

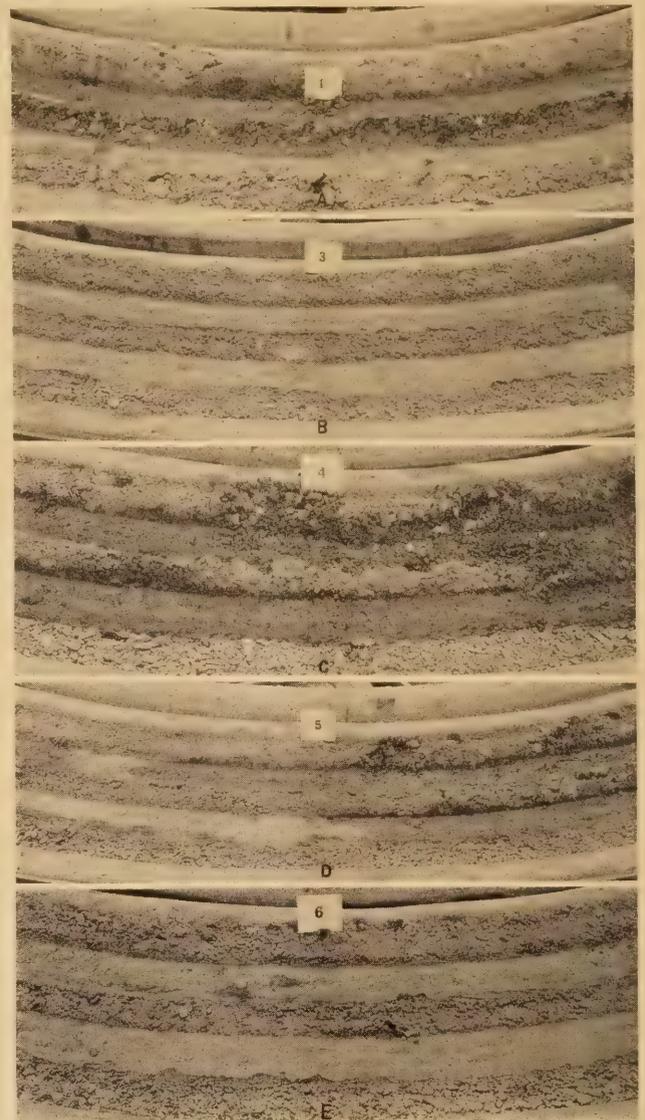
FIGURE 7.—APPEARANCE OF CIRCULAR TRACK TEST SECTIONS AFTER 210,000 WHEEL-TRIPS (END OF TEST). A, SECTION 1 HAD FAILED; SECTION 2 (NOT SHOWN) HAD PREVIOUSLY FAILED; B, SECTION 3 REMAINED IN GOOD CONDITION (COMPARE WITH FIG. 6-C); C, SECTION 4 RUTTED AND SURFACE BROKE, EXPOSING BASE; D, CONSIDERABLE DISPLACEMENT OCCURRED ON SECTION 5 (COMPARE WITH FIG. 6-E); E, SECTION 6 REMAINED IN GOOD CONDITION (COMPARE WITH FIG. 6-F).

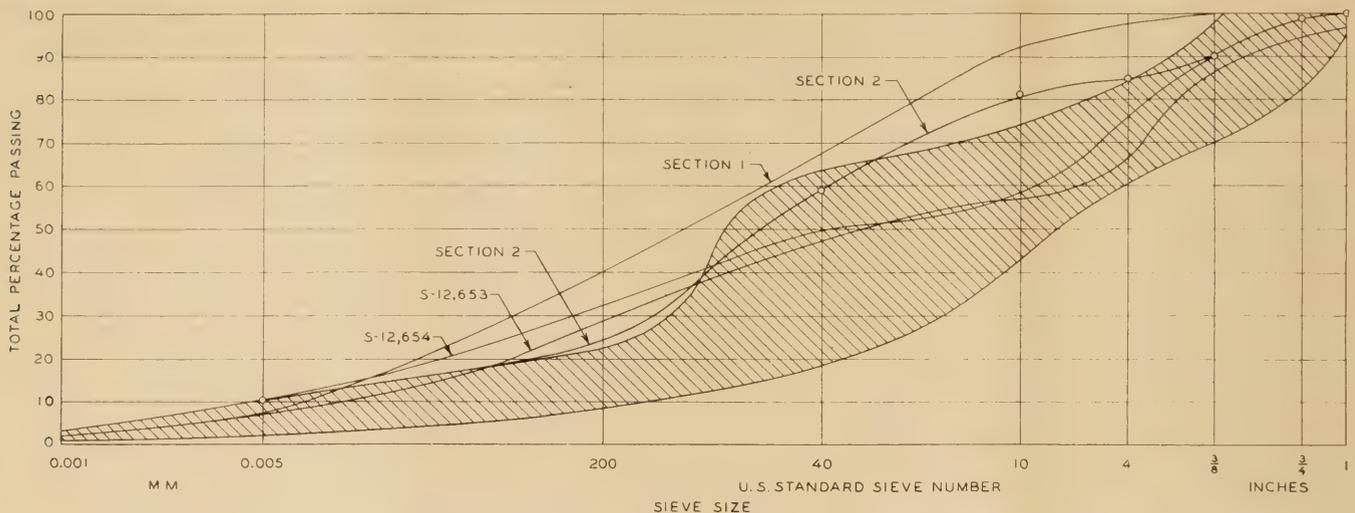
FIGURE 8.—GRADING BAND OF SATISFACTORY CINDERS AND GRADING CURVES OF UNSATISFACTORY CINDERS.

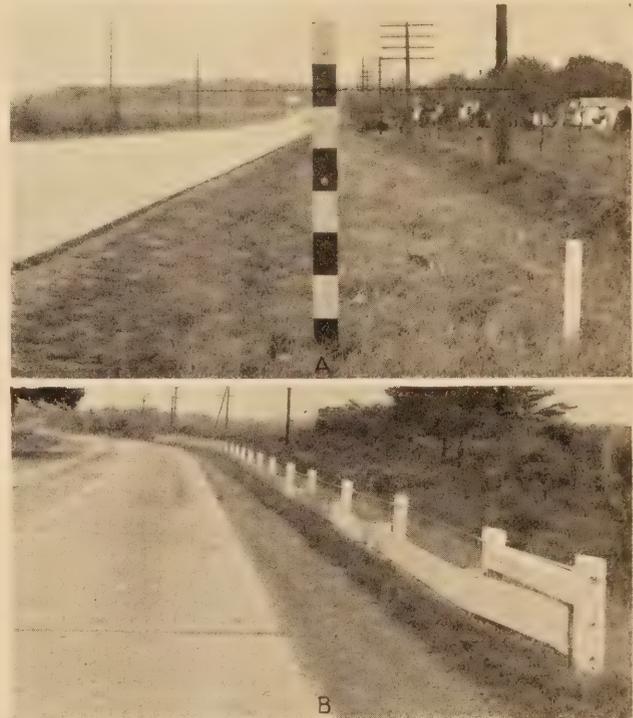
FIGURE 14.—A, 3-INCH BOARD COVERED WITH REFLECTORIZED MATERIAL SUITABLE FOR USE AS A MARKER OR DELINEATOR; B, END PANELS OF GUARDRAIL REFLECTORIZED WITH BEADED WHITE PAINT.

Table 13 shows the rating factors for a number of devices used to mark guardrails and culvert headwalls along the test route. All of the markings were about equally effective, except for the guardrail that was painted white and reflectorized with glass beads which was particularly outstanding (fig. 14–B). For traffic to move with any degree of safety during blackouts, all bridge piers, abutments, and other objects within the roadway or so near as to constitute traffic hazards should be marked either with a cluster of reflecting buttons or a reflectorized sign within 18 inches of the elevation of the roadway surface, or reflectorized with beaded paint or reflectorized materials from a point as close to the pavement surface as practicable to a height
